ANALYSIS OF HOT SECTION FAILURES ON GAS TURBINES IN PROCESS PLANT SERVICE

by
Ian Hunter
Senior Engineer
Joe Daleo
Vice-President
Jim Wilson
Technical Director
and
Keith Ellison
Senior Engineer
BWD Turbines Limited
Ancaster, Ontario, Canada

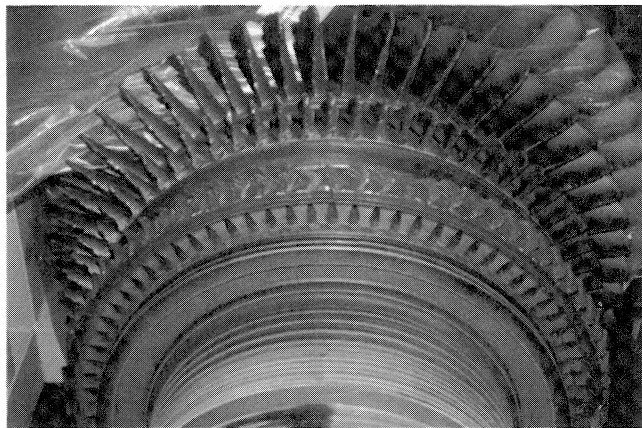
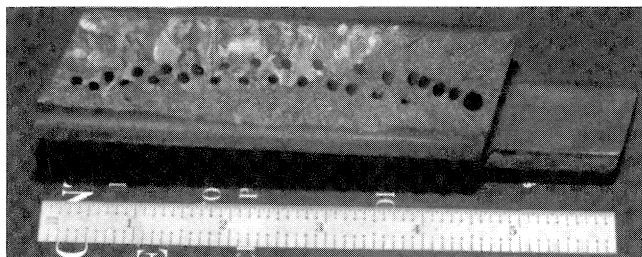
Figure 1. Damage to All Four Rows of Blades in Large, Generator Drive Gas Turbine. (The fracture surface (in the root section) of this particular blade is shown in the lower photograph.)

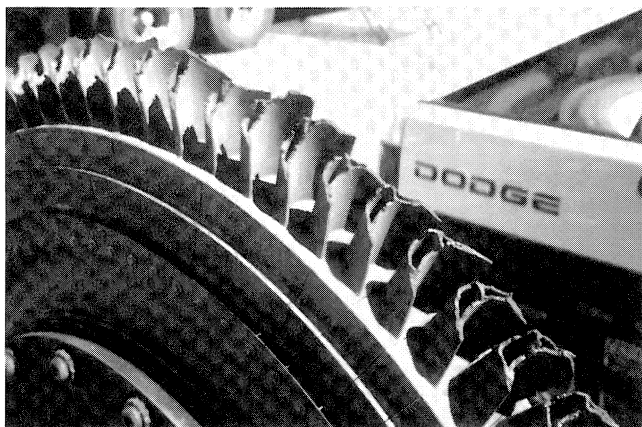
Figure 2. Damage to Hollow-Cored First Stage Turbine Buckets in a Mechanical Drive Gas Turbine.

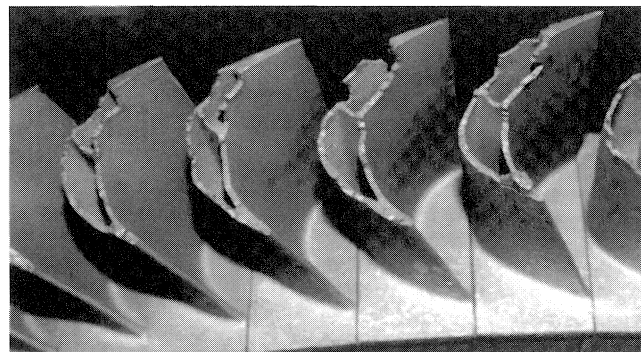
The failure was characterized by loss of airfoil material on all the first stage buckets down to 60 percent to 70 percent height (Figure 5). The last inch of the trailing edge tip was still intact in most cases.

Figure 5. Failed First Stage Buckets. (The volume and shape of airfoil material loss was very similar on all the buckets in the row.)

The pertinent overhaul documentation was reviewed and it was found that the failed buckets had been a replacement set made up from three previously used groups of components. However, it appeared that refurbishment on these had been done with incomplete knowledge of the metallurgical reasons why the components had originally been retired.

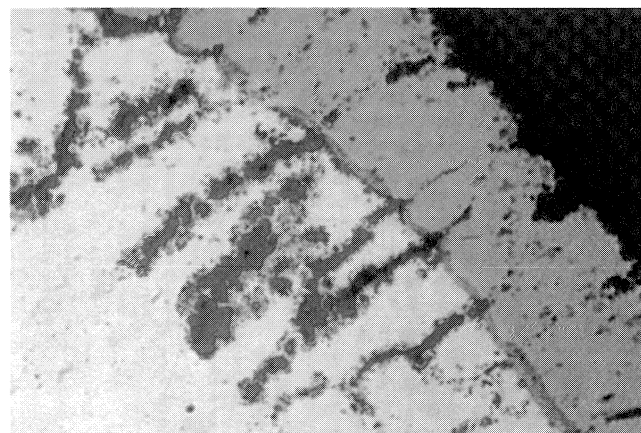
The metallurgical analysis revealed extensive, pre-existing oxidation/corrosion damage remained beneath the refurbished aluminide coating on the external side of the airfoil (Figure 6), while the original platinum modified aluminide coating was never actually removed from the inside surface. Heat treating the buckets in this condition had resulted in localized melting and excessive diffusion of the coating into the IN-738LC base metal. In thin-walled components, this not only locally destabilizes the alloy microstructure, but also results in a thick, brittle layer on the internal surface. While acceptable creep rupture properties were obtained, the regenerative heat treatment cycles used did not fully restore the IN-738LC microstructure (Figure 7).

Figure 6. Photomicrograph Illustrating the Damage to the Base Metal Below the External Coating on One of the First Stage Buckets.

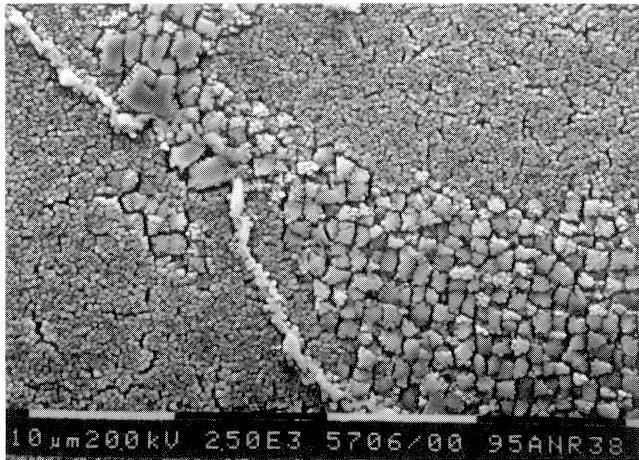
Figure 7. Scanning Electron Micrograph of First Stage Bucket Alloy Illustrating That the Component Had Not Been Properly Heat Treated. (The microstructure consisted primarily of a single size gamma prime distribution with small isolated islands of the normal duplex gamma prime precipitate structure.)

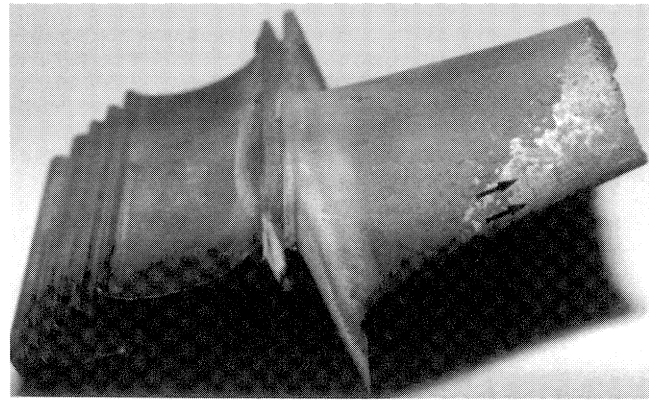
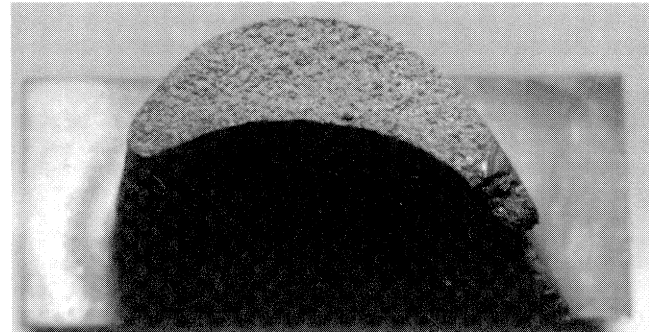
A catastrophic failure of the first stage turbine buckets occurred. All the bucket airfoils (which were of solid design) fractured at approximately mid-height (Figure 9), and impact damage was sustained by the downstream gas path components.

The primary fracture on the buckets had propagated in an intergranular mode across the entire airfoil section. The fracture surfaces at the leading edges appeared typical of high temperature creep or thermal-mechanical fatigue (Figure 10), while the remainder was more characteristic of intermediate temperature creep rupture crack growth and brittle impact overload. Evidently, one bucket airfoil had failed, initiating an impact cascade that resulted in the fracture of the other buckets in the row.

Figure 9. Failed First Stage Bucket. (The upper photograph shows that the aluminide coating was missing below the fracture surface and a secondary crack was present (highlighted by arrows). The mode of fracture was intergranular across the airfoil section (lower photograph).)

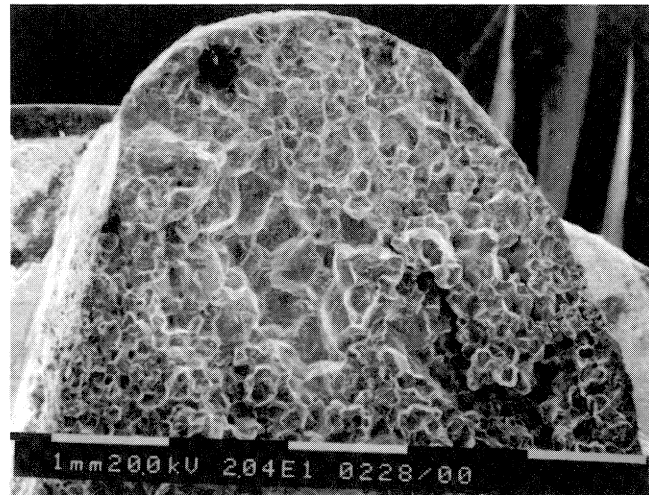
Figure 10. Scanning Electron Fractograph of Failed First Stage Bucket Leading Edge. (The fracture had propagated in an intergranular mode.)

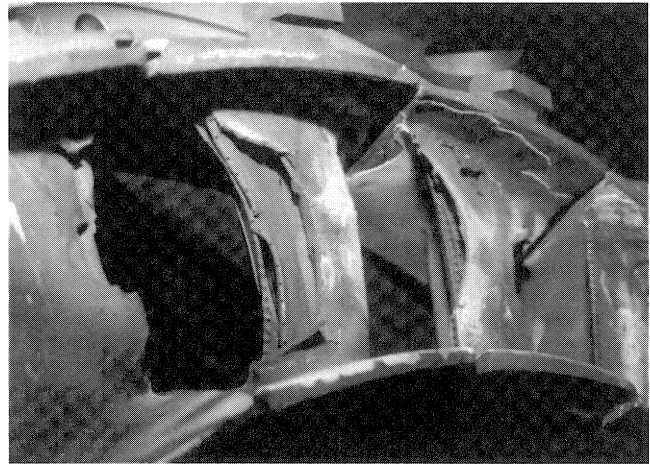
Figure 12. Row of First Stage Vanes Showing Burning Damage as Viewed from Trailing Edge Side.

In examining the set of vanes, particular attention was given to those components that were among the least damaged and, therefore, could provide better opportunities for determining where the failure originated. Several vanes were subsequently identified containing features that appeared to be representative of different stages in the progression of the damage. From these, it was evident that local high temperature oxidation attack had started just downstream of the S1 film cooling holes at the outer shroud end of the row (vane in Figure 13). The airfoil wall became breached and as the damage progressed along the row of holes, the cooling air flow became more disrupted, exacerbating the overheating situation and extending the area of damage. The vane cavity became exposed to the hot gases leading to the damage in the trailing edge region apparent in Figure 12.

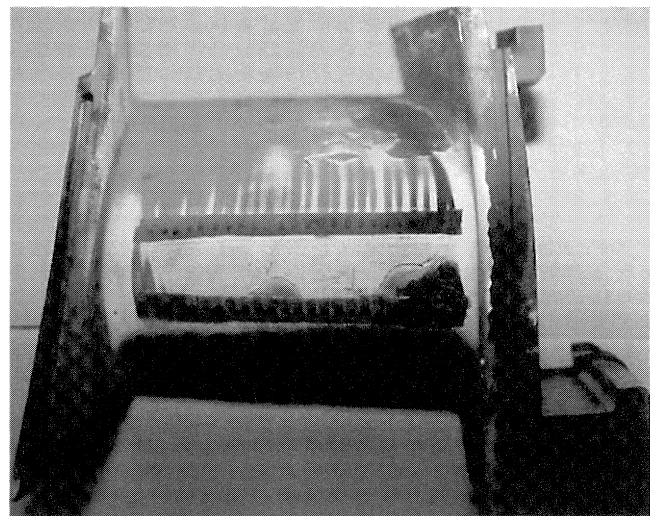
Figure 13. First Stage Vane Showing That Localized Oxidation Attack Had Commenced at Outer Shroud End of the First Row of Suction Side Film Cooling Holes.

Based on the location of the damage, the observed cooling air flow patterns and results from simulations on a finite element based heat transfer model of the vane, it was concluded that aggressive oxidation attack had occurred. This was due to locally excessive metal surface temperatures that had been caused by the failure of the cooling air ejected from the S1 row of holes to form a sufficiently persistent and protecting film over the airfoil surface immediately downstream. It appeared that this feature of the vane cooling design exhibited only marginal effectiveness under the uprated operating conditions. Among the contributing factors was that the S1 holes were located in a high curvature part of the airfoil, resulting in the angle of the ejection holes being unusually steep.

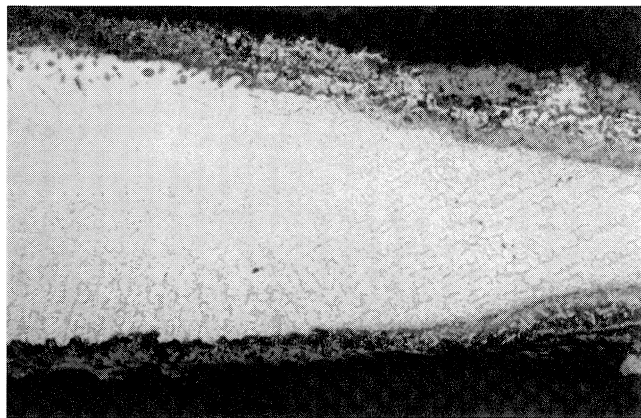
Another important aspect of the failure was that, while all vanes in the set sustained damage, there was significant variability in the degree of damage due to differences in the age and condition of the individual components at the beginning of the service period in question. In general, the damage on the older vane segments was significantly worse due to reduced safety margins on leading edge wall thicknesses (Figure 14). The uncoated internal and cooling hole surfaces had been oxidizing and reducing the ligaments between the holes, which also contained small thermal-mechanical fatigue cracks.

Figure 14. Photomicrograph Showing Level of Pre-existing Oxidation Damage on Internal and External Surfaces of First Stage Vane Wall Section in the Vicinity of the First Row of Suction Side Film Cooling Holes. (Photograph, $\times 60$)

Essentially, the weakened line of cooling holes acted as “perforations” along which the failure readily progressed. The inclusion in the vane set of components that had already accumulated 50,000 hours of service and been through four repair cycles was, in hindsight, probably not an appropriate strategy for a turbine about to be operated under even more demanding temperature conditions.

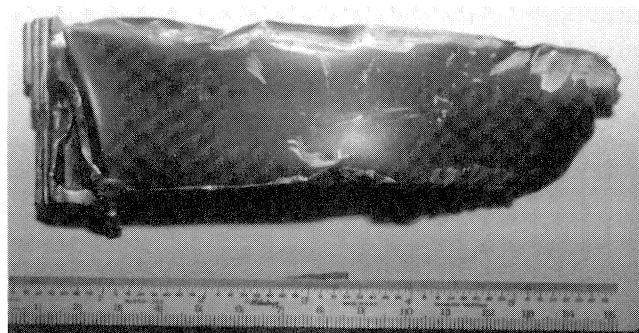
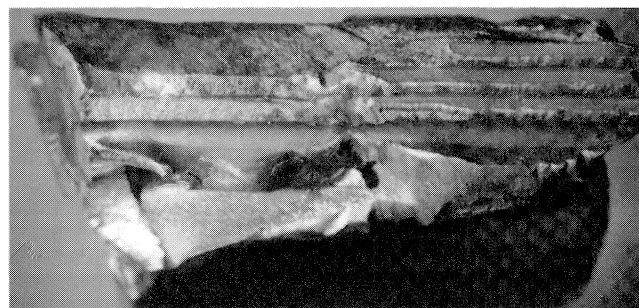
A last stage power turbine blade manufactured from Nimonic 90 failed after about 24,000 hours of operation. The fracture occurred in the root section of the blade (Figure 15) and a number of other blades were identified as having cracks at the same location. Changing process requirements at the site had dictated that the driven equipment run at lower power and speed levels. The failure of the blade occurred after operation of the gas turbine under these new conditions.

Figure 15. Failed Last Stage Power Turbine Blade. (The top fir tree serration crack and failure path along the second serration are seen.)

The blade root exhibited multiple fracture initiations on both first and second root serrations. The blade had failed across the second fir tree serration. Metallurgical examination of fracture surfaces and cracks revealed features consistent with high cycle fatigue. Fatigue striations were clearly visible and exhibited a repeating pattern at approximately eight-cycle intervals (Figure 16). No material defects or other forms of degradation were found.

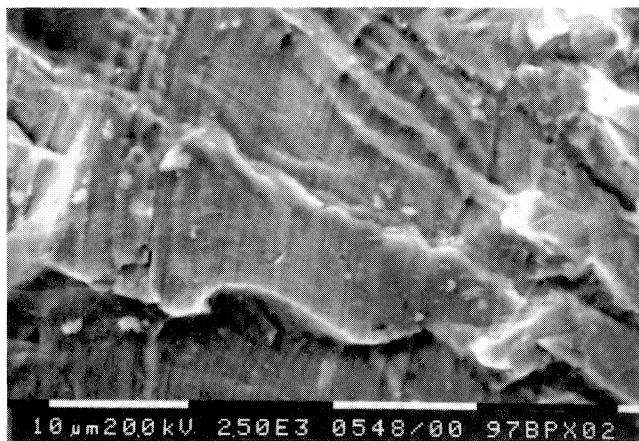
While having found clear evidence identifying high cycle fatigue as the metallurgical mechanism of failure, additional information was necessary to help understand the cause. Accordingly, a mechanical analysis was undertaken to determine whether some feature of the design had predisposed the power turbine blade to fail in fatigue.

Figure 16. Scanning Electron Fractograph of Cracked Last Stage Power Turbine Blade.

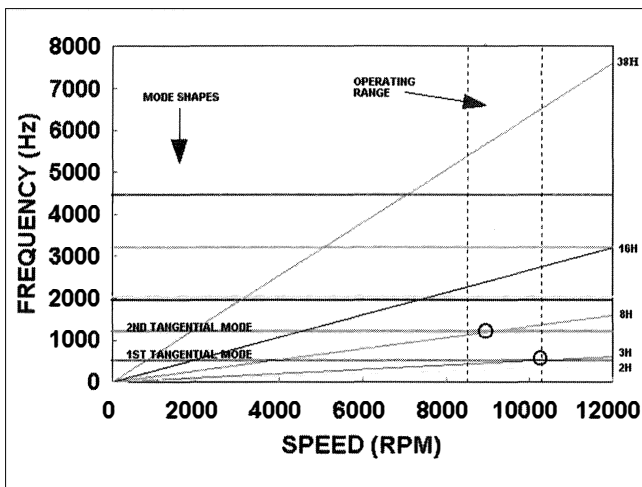
A three-dimensional finite element model of the blade was created. The first six vibration frequencies and corresponding mode shapes were calculated for the model. The Campbell diagram presentation of the results is given in Figure 17, with the interferences of interest highlighted. A resonance existed in the first tangential bending mode at 10,200 rpm with the third harmonic of running speed. A different resonance existed in the second tangential bending mode at 9100 rpm with the eighth harmonic, which corresponded to the number of combustors on the engine. It is likely that the first mode resonance initiated cracks in

the failed blade during short term operation transients to 10,300 rpm, followed by propagation to failure under resonance conditions for much longer times at 9100 rpm. The cracked blades probably initiated cracks due to the excitation during operation at the lower speed. The location of the calculated highest dynamic stresses correlated with the observed crack initiation points.

Figure 17. Campbell Diagram for Last Stage Power Turbine Blade. (The interferences of interest are highlighted.)

The freestanding design of the last row of power turbine blades was somewhat unusual for a variable speed machine in which it is often impossible to avoid some resonant conditions in the operating range. Lashing wires or interlocking tip shrouds are typically utilized to control blade vibrations. Prompted by the failure analysis described here and further occurrences on turbines at the same site and elsewhere, the turbine manufacturer acknowledged that a problem existed and undertook a complete redesign of the blade.
